ENDANGERED SPECIES OBSERVER PROGRAM

Dredge *OUACHITA* - Brownsville, TX
USACE, Galveston District

02/26/95

INCIDENT REPORT OF SEA TURTLE MORTALITY AND DREDGING ACTIVITY

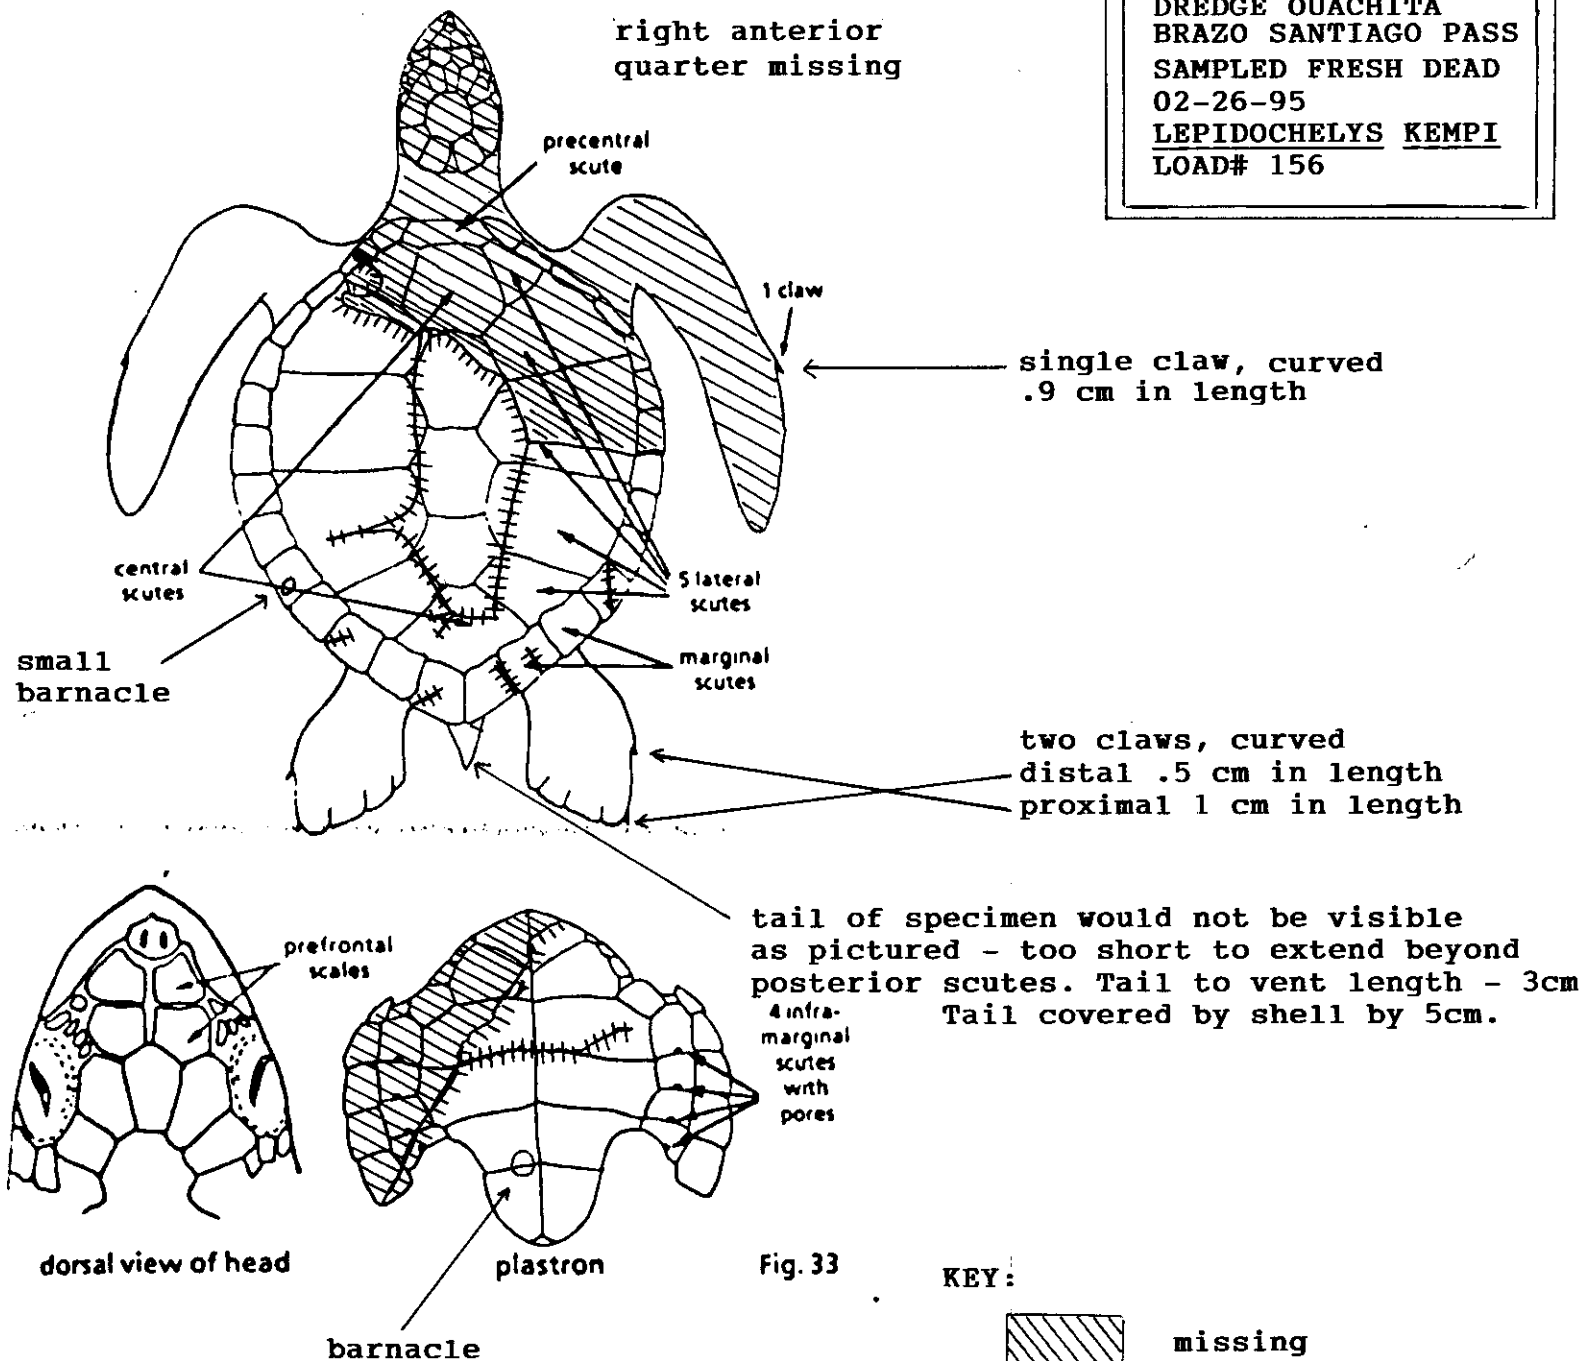
DREDGE OUACHITA
BRAZO SANTIAGO PASS
SAMPLED FRESH DEAD
02-26-95
LEPIDOCHELYS KEMPI
LOAD# 156

An observer patrolled the hopper at 1130 and did not see a turtle in the forward lander. Just prior to dumping the load, the observer on watch saw a turtle caught in the forward lander. He signalled to the drag tender that he wanted to enter the lander prior to flushing the hopper. The drag tender shut off the pumps to allow the turtle to be removed. This turtle was probably taken in the last half hour of the load. The turtle was dead, badly fractured, missing the right anterior quarter of the body, including the head. The body cavity was empty except for the lining, which remained intact. The lining was purple, light purple, red, and bluish in color. No foul odor was present. The carapace was olive grey, fading to a lighter cream color at the outer edges of the marginal scutes. The plastron was a creamy, pale yellow. The distal ends of the flippers were flecked with grey. The fore flipper had one curved claw, .9cm. in length. The rear flippers had two claws each, the proximal 1 cm. and the distal .5 cm. in length. Fresh blood was present in the cavity.

Body cavity: The body cavity was empty, except for the lining, which remained intact. Fresh blood was present and the lining was purple, light purple, red, and bluish in color. No foul odor was present.
